DELAWARE RIVER BASIN
COOPER RIVER, CAMDEN COUNTY
NEW JERSEY

COOPER RIVER PARKWAY

PHASE I INSPECTION REPORT NATIONAL DAM SAFETY PROGRAM

NJ 00393

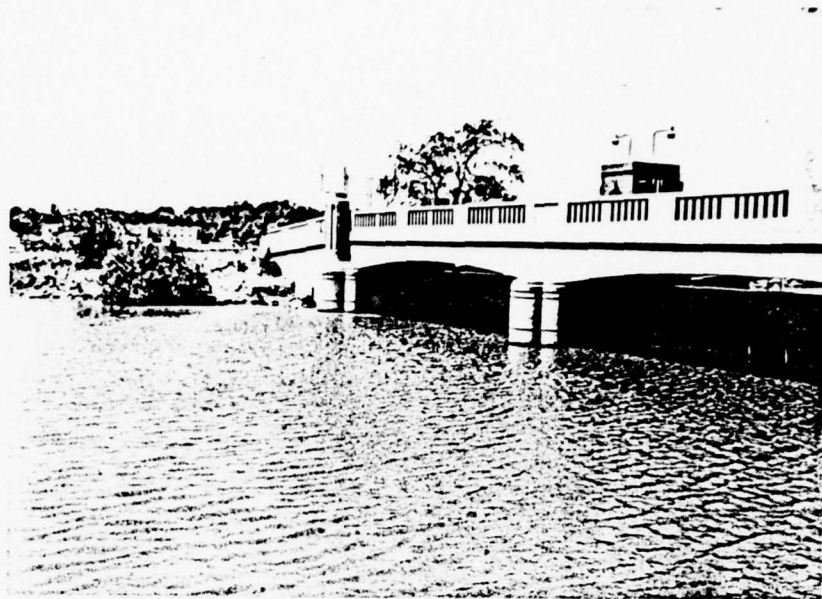
Upstream view of Structure
June 1978

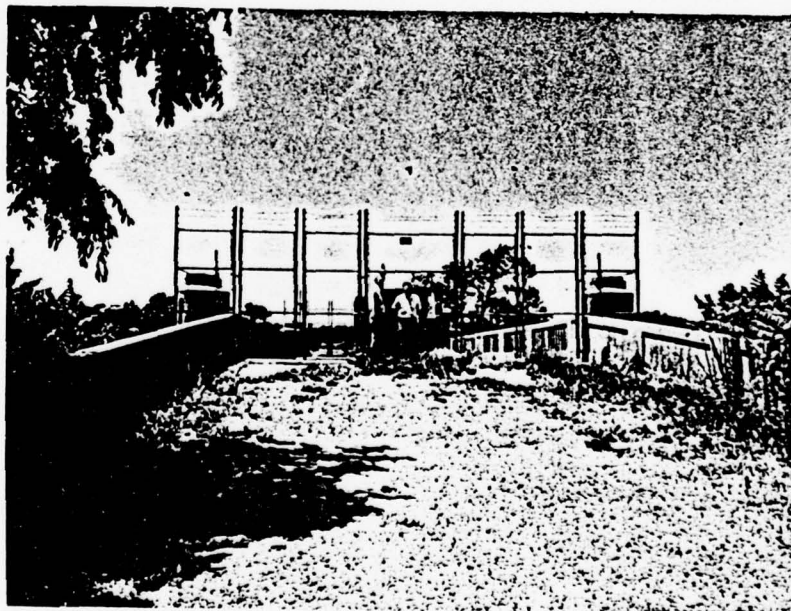
Some concrete spalling and deterioration was observed at the concrete abutments and wing-walls. The railing, equipment housings and superstructure are in acceptable condition.

East Abutment
June 1978

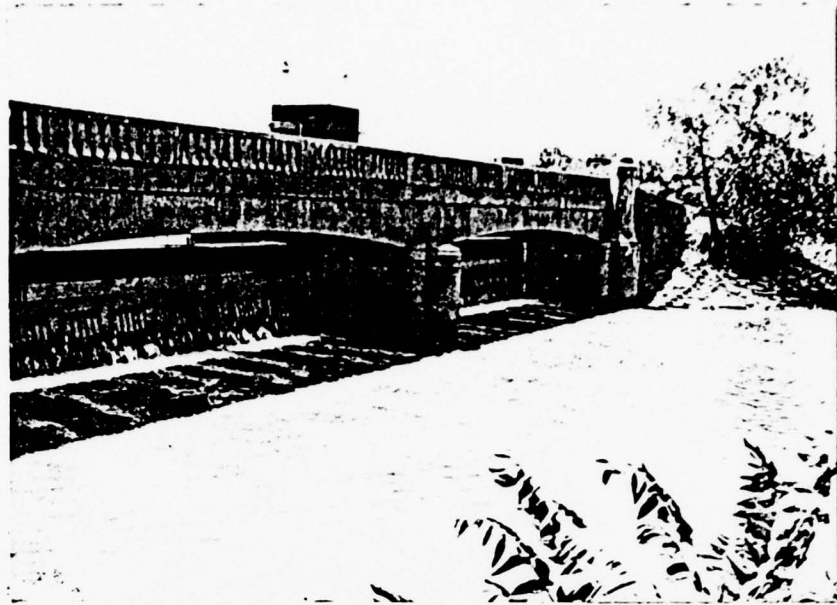
Downstream view of Sluiceways
June 1978

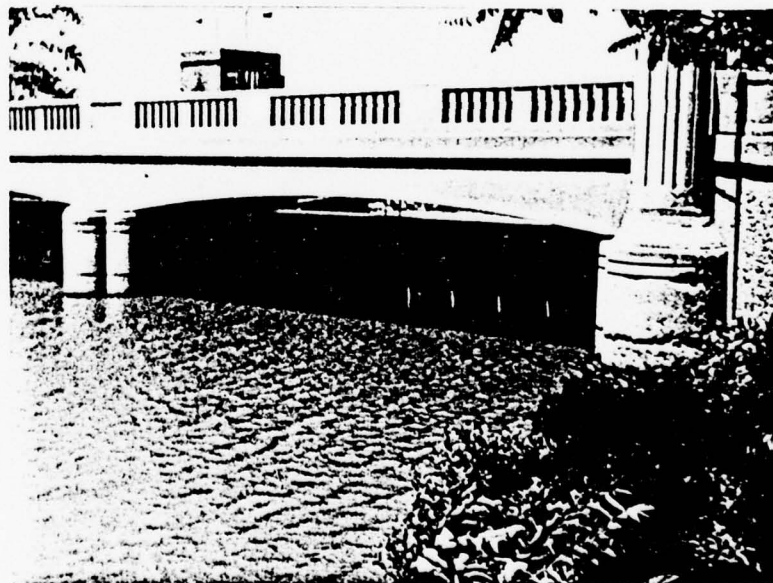
Upstream of Sluiceways and East Abutment
June 1978

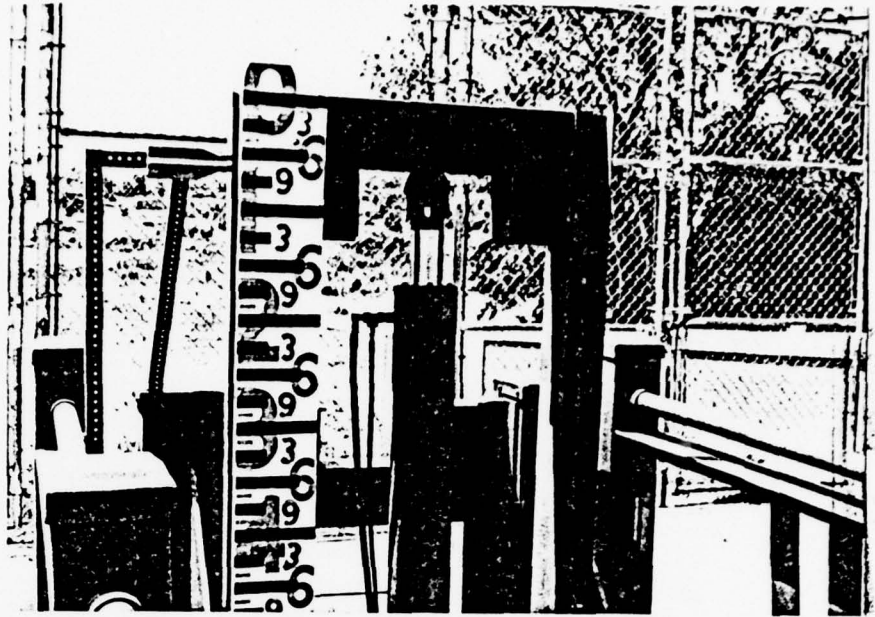
Hydraulic Cylinder
July 1978

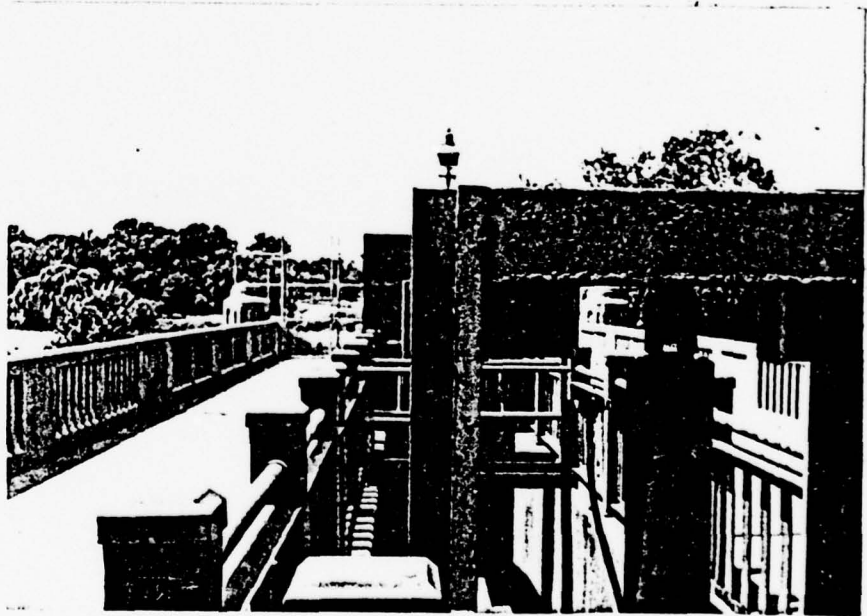
Initially, the tide gates were raised and lowered by screwlift hoists, which permitted the gates to be raised to their full height. The screw stems were attached to davit arms near the bottom of the gates. Difficulties were experienced in operating the gates with the hoisting mechanism originally installed, so in 1975, the screw hoists were replaced by hydraulic piston hoists. They are operated either separately or simultaneously. The hydraulic piston hoists are attached to lifting frames anchored to the bridge, and the gates can be raised only a maximum of approximately 4 feet. A crosswalk was also installed over the gate slot on the bridge deck, which limits the lift height to which

Lifting Apparatus
July 1978

It is recommended that within three years from the date of approval of this report, the owner review the hoisting arrangement to see if modifications could be made to permit a greater gate opening, both with regard to obtaining added release capacity and for permitting access to the lower end of the gate for inspection and maintenance.
